Inspection and Structural Repair of the Fire Damaged Library Piers of the Glasgow School of Art

William Calder

David Narro Associates, Edinburgh.
Máster en Rehabilitación Arquitectónica por la Universidad de A Coruña

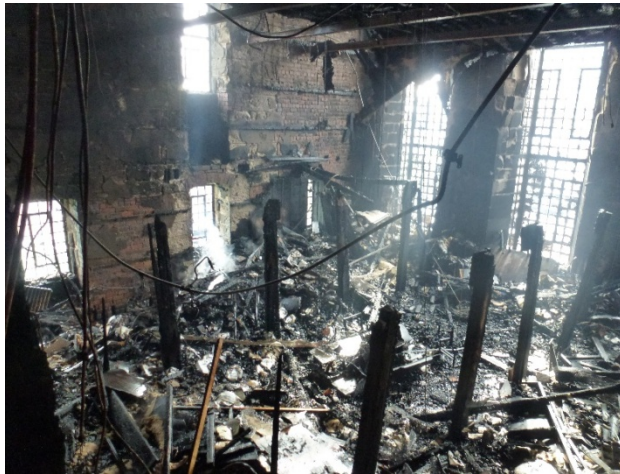
1. Mackintosh Library as found after fire

On the 23rd of May 2014 the west wing of the iconic Mackintosh School of Art in Glasgow was severely damaged by fire. The fire, starting at basement level, quickly spread throughout the internal timber lined voids that formed part of an innovative hot air heating system. This made it incredibly difficult for the firefighters to contain the fire and resulted in extensive damage to the west wing of the building.

Several studios were affected and much of the roof was destroyed but the most important damage occurred in the Mackintosh Library. The library was an intricate space which stretched over two levels. A mezzanine level supported on dark timber elements split the space vertically. The suspended lighting, bookcases, balustrades, chairs and work tables all feature art nouveau motifs.

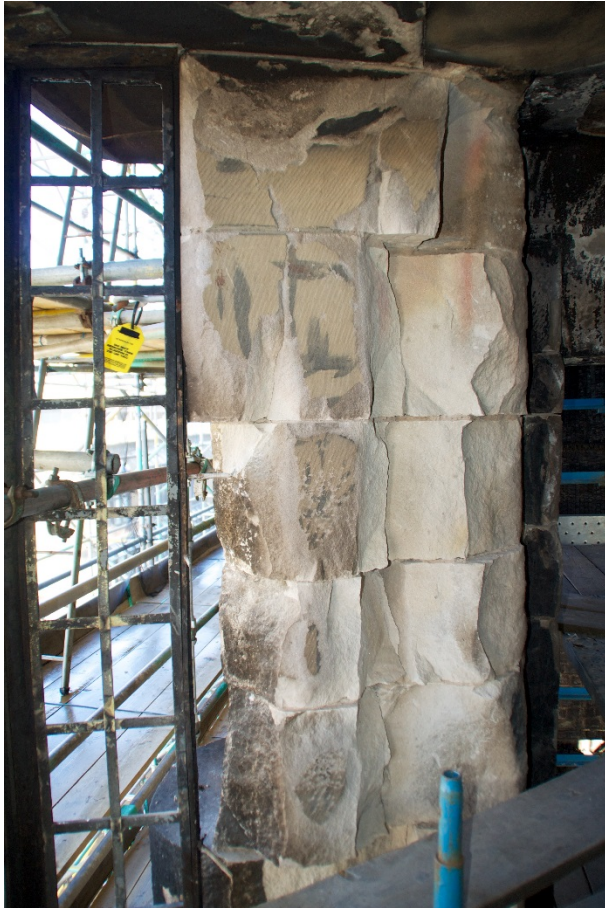
The location of most severe damage to the fabric of the building has been the stone piers of the west gable that form the vertical sections between the triple height library windows. These consist of masonry blocks with no rubble infill. Photos taken just after the fire show clear cracking and loss of material of the block surfaces due to the extreme heat generated during the fire and possibly more importantly the rapid cool down caused by dowsing the stones in water while extinguishing the fire (fig. 4). It was determined that the piers had lost about 6-7% of the area of original stonework as an average value with those areas worst affected losing up to 10%. This was not considered to be structurally significant due to the large factors of safety usually found in bearing masonry construction. Many of the blocks of masonry had cracked throughout their entire width and this cracking seemed to follow a pattern vertically, effectively splitting the columns front to back. This had more serious implications as it could affect the overall stability of the columns by increasing their slenderness.

4. Loss of masonry of the library piers

The stone in the piers is fine grained sandstone, a very consistent material that comprises mainly silica. The damage that occurs at high temperature is usually mechanical and not chemical resulting from expansion. The damage is due to a stress differential between different parts of the stone blocks. As the exterior surfaces of the blocks are heated quickly, it expands quickly. The interior body heats up and therefore expands at a steadier rate and creates a difference in stress within the block. This ultimately results in a fracturing of the block in circular layers. This is shown by the curved faces of the blocks of the pier where before the blocks were square. This process also occurs in reverse during cooling and could again be more critical due to the sudden nature of dowsing the stone in water. It is interesting to note that although unavoidable in order to save the building, it can in fact be the process of extinguishing the fire that does the most damage to its fabric.

More than a year on from the fire, a secondary type of stone damage is being noticed that is less severe but could cause problems in the future. It is shown in the form of spawling of the weakened and more friable stone surfaces due to weathering effects. This is most common alongside cracking in the stone where moisture can enter.

It was concluded from the inspections that some temporary stabilisation was required in order to secure the piers laterally. This consisted of the bracing, front to back of the piers at four intervals, effectively pushing the piers together.

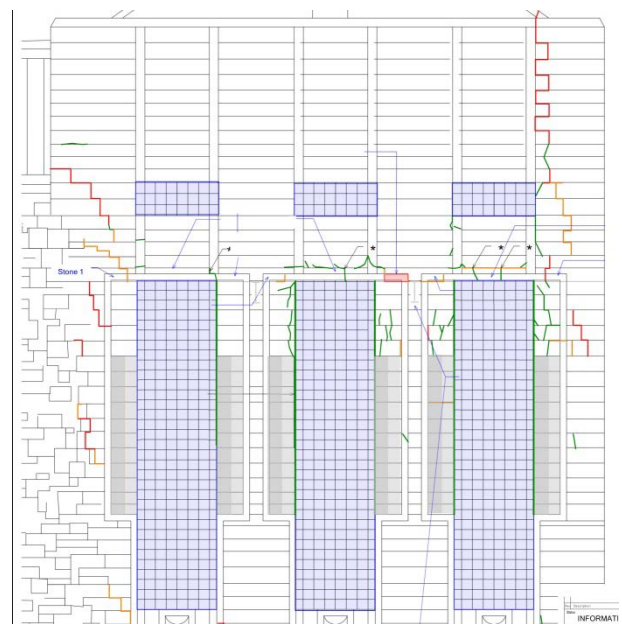
In August 2014 a thin section of one of the carved stone blocks next to the lintel of the large openings fell from the building and landed in the carriageway of Scott Street. It fell within the fenced off area but this motivated an immediate inspection from ground level and followed by a detailed high level inspection by crane of the exterior surface. The individual blocks cracking patterns were mapped onto a drawing in order to build a global image of the effects on the façade (fig 5). It concluded that the most significant damage to the masonry occurred at the head of the piers with many cracks propagating through the blocks (shown in green). It also identified that each of the large stone lintels had split throughout their entire body.

5. Mapping of crack patterns on the facade

The global image shows opening up of the mortar joints down the north edge of the façade in a diagonal pattern. A vertical opening up on the joints was also identified running down the south edge which extended a considerable distance. These patterns are understood to be related to an outward movement of the façade due to actions of the fire. Due to the

intense heat of the fire in the library space, the long steel RSJs supporting the floor of the gallery above expanded, significantly. As they were constrained in wall pockets, this induced significant stresses in the fabric of the façade accounting for the localised cracking of the masonry blocks and lintels at the pier heads and has led to the more significant movement of the façade. It is concluded that the splitting of the lintels is a result of mechanical stresses due to the shift of the façade and not due to the stresses related to heat. The lintels do not show any further damage aside from minor surface spawling and discolouration. The stone fall near the middle lintel is thought to be related to this mechanical stress. The shearing off of the section is assumed to have happened at the time of the fire but it was held in place for several months by the mortar.

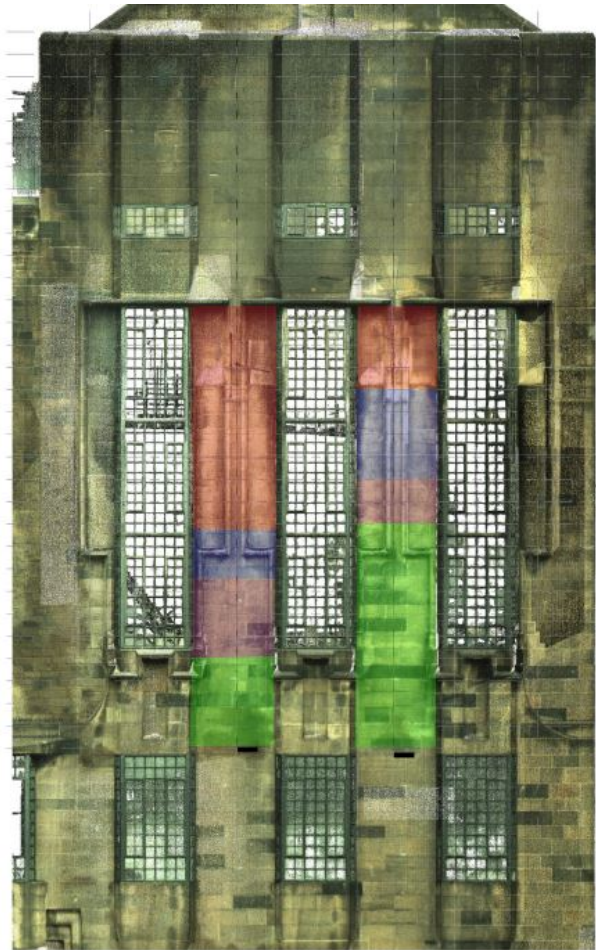
A digital scan of the west gable was carried out prior to and following the fire by the Glasgow School of Arts Digital Design Studio. This has proved incredibly useful as it has allowed the comparison of the current position of the façade with reliable benchmark data. The scans have shown a clear increase in horizontal displacement towards the heads of the columns which is displayed in fig 6 with the red sections indicating a maximum displacement of 15-20mm and the green indicating a minimum displacement of 0-5mm. These results support the idea that the columns have been pushed out at the head.

6. 3D digital scan comparison showing displacement of piers

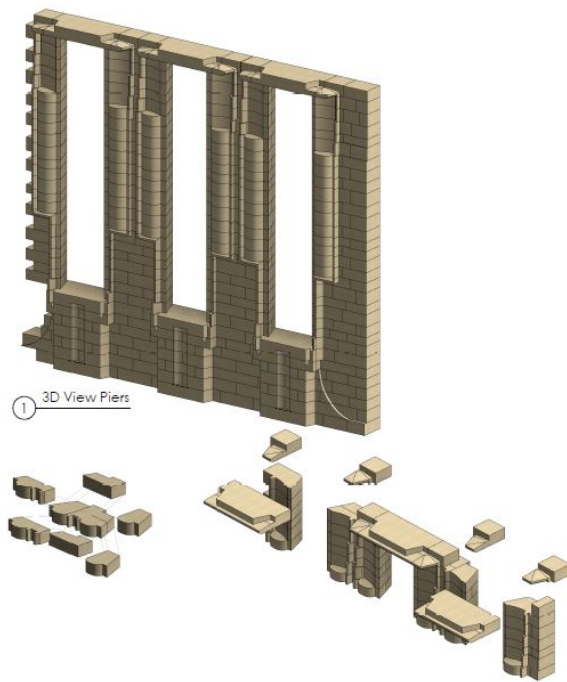
As part of the repair, the piers will be completely dismantled. In order to understand and keep a record of the individual blocks in the piers, a 3D AutoDesk Revit model was produced. Each of the blocks was modeled individually and the piers were effectively constructed digitally within the model. Furthermore each of the blocks was given a reference which is collated along with their individual volume in a stone schedule. This will facilitate the process of labeling and identifying individual blocks during the dismantling and assessment process (fig 7).

7. AutoDesk Revit model of piers using individual blocks

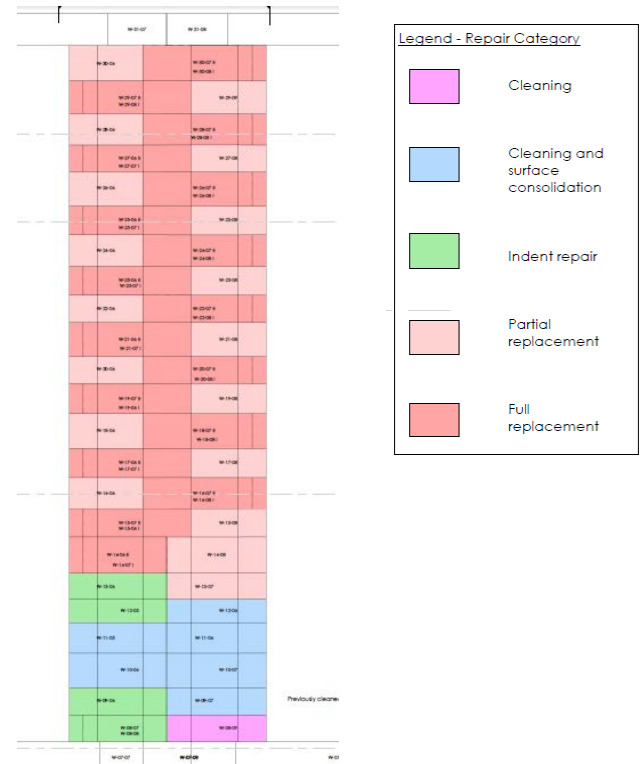
8. Section showing proposed dowel repair of masonry blocks

By means of close inspection of the entire piers, the needs of each stone block have been assessed. This ranges from the most severe cases where complete replacement is necessary to the least where a surface cleaning would be sufficient. Diagram 8 shows the proposed level of repair that each block requires. The repair measure that falls between these two extremes and will be used for the majority of the blocks involves

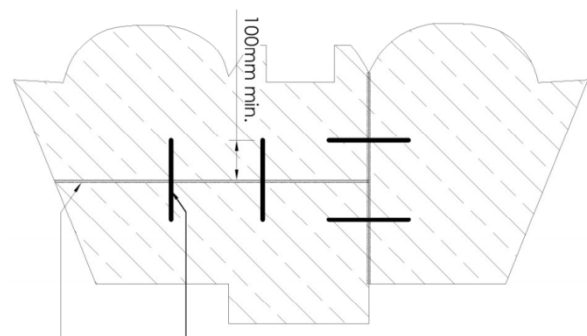
9. Section showing proposed dowel repair of masonry blocks for partial repair.

salvaging sections of the blocks where possible and incorporating new sections as a partial repair. The individual elements will be bonded with stainless steel dowels resin anchored into one another as per diagram 9.
